realSensTM Service Value Proposition

Natural Gas Leak Anomaly Report

Gas Anomaly 10525-01B (sample)

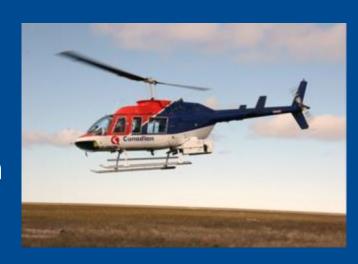
-Small amounts of gas are very visible. (See Test Image) -Considering wind speed, (40 kmh) the actual amount of gas present in this image is less than ½ of a SCF **Helicopter Pass** 12:19:03 .107em0

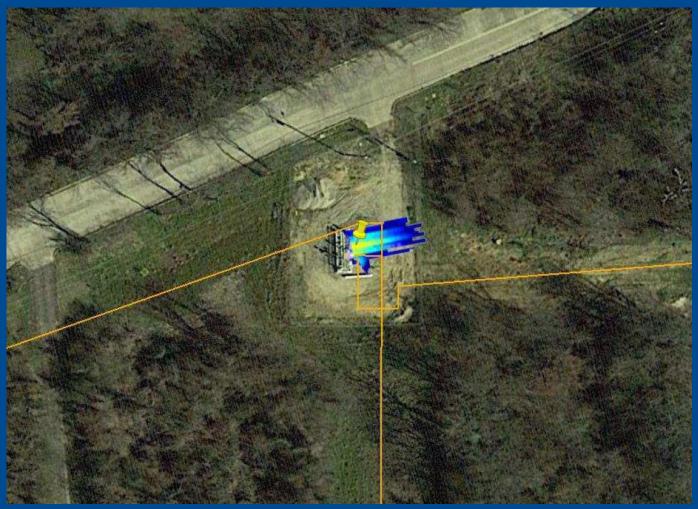
Anomaly Image

A relatively large gas anomaly indication originating from an open field. This is the second pass over the same location as gas anomaly 10525-01A.

Wind direction was changing direction between North and South and averaged 8-10 miles/hour. There is a relatively large location uncertainty (estimated at over 100 feet) due to the wind conditions.
