# Non Metallics Inspection

Integrating Non-Destructive Testing  
with Quality-Safety-Service and Cost  
Effectiveness

# Non-Destructive Examination Technologies for the Inspection of Butt Fusion Welded High Density Polyethylene Joints

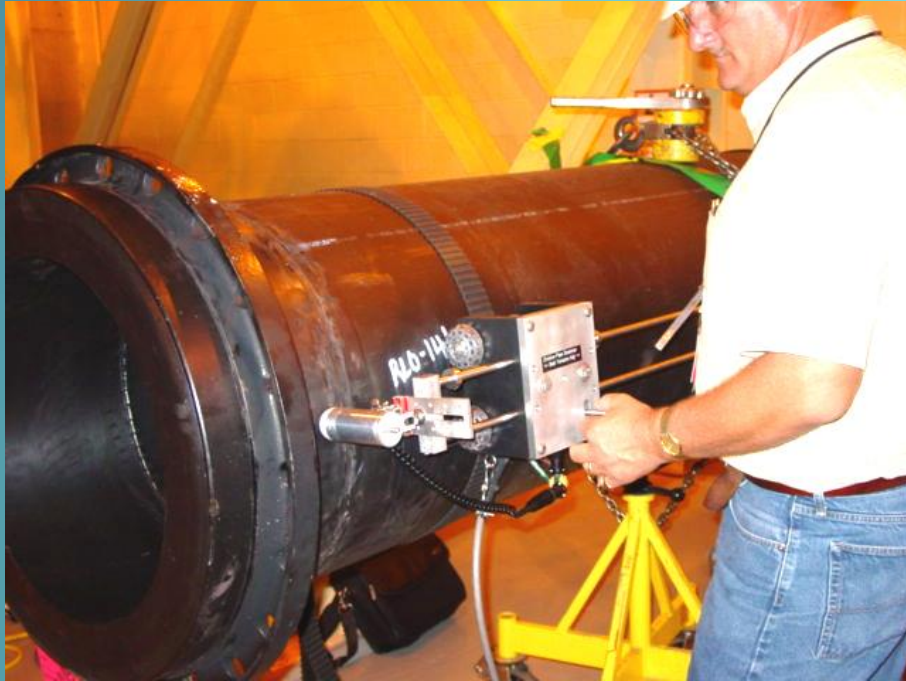
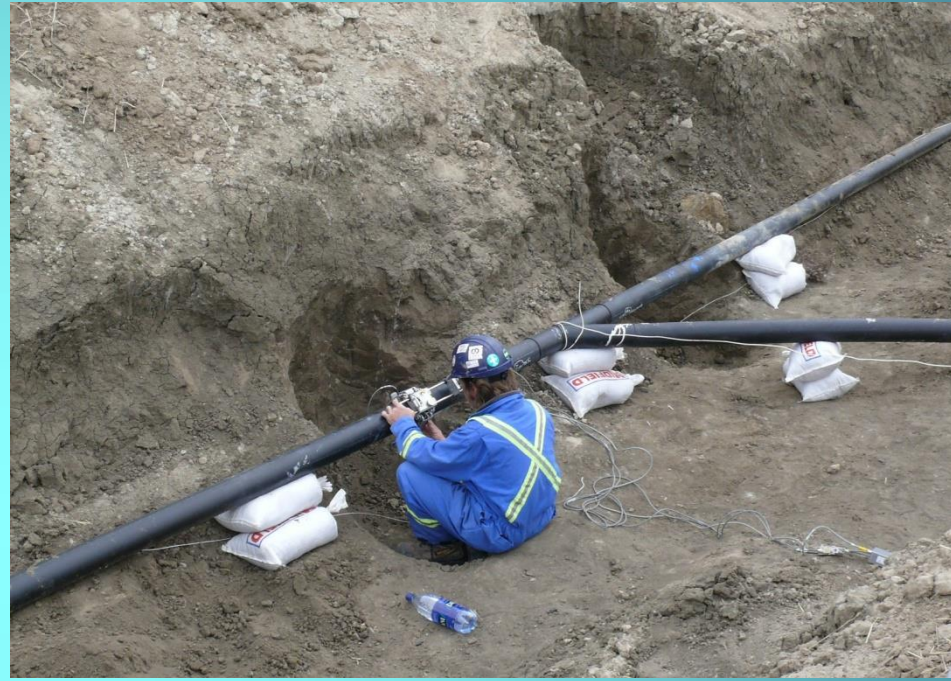
# Field Scanning

- The Evisive scanning can be provided using:
- automated and manual pipe scanning
  - manual hand scanning for complex geometries, spot checks or large objects (i.e. tanks)
  - Laboratory scanning, including very complex geometries

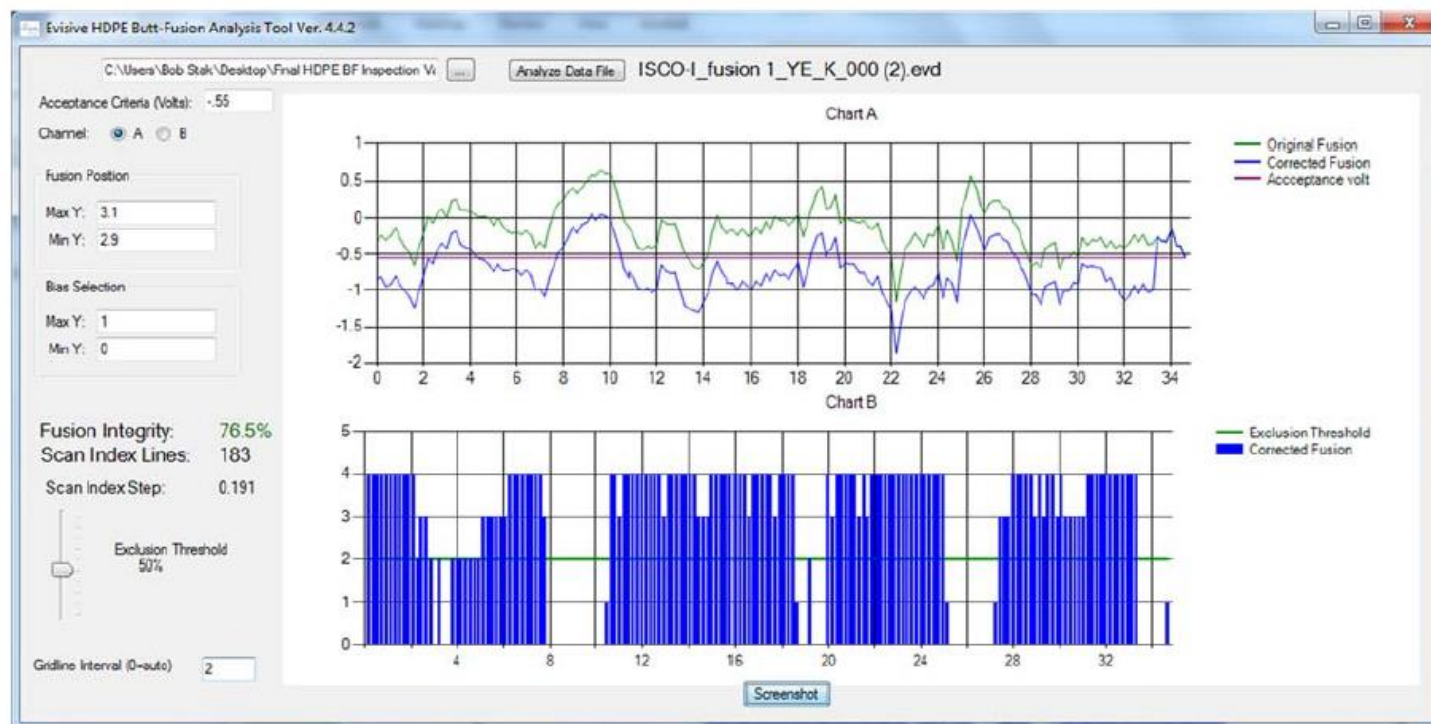
# Evisive Scan: Pass/Fail Software

"A" Channel Analysis Results showing the selection of ductile threshold of 76.5%

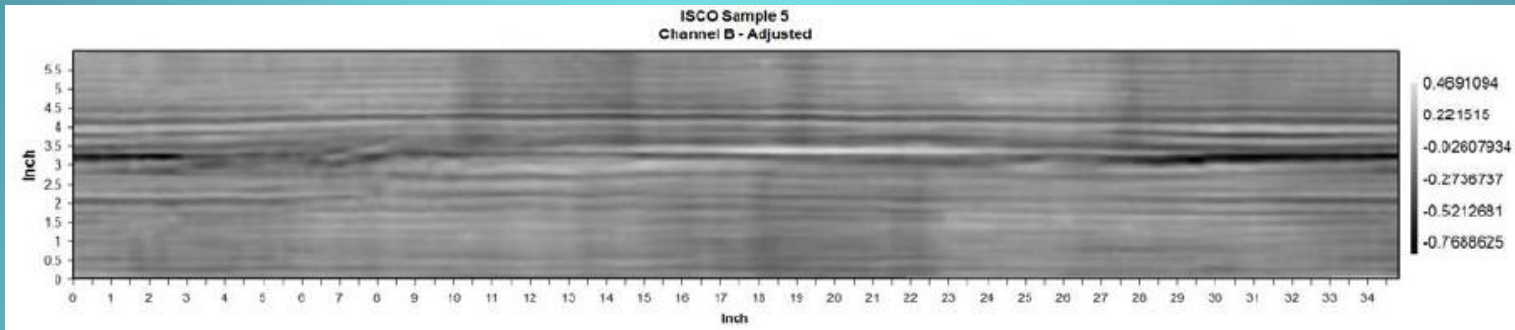
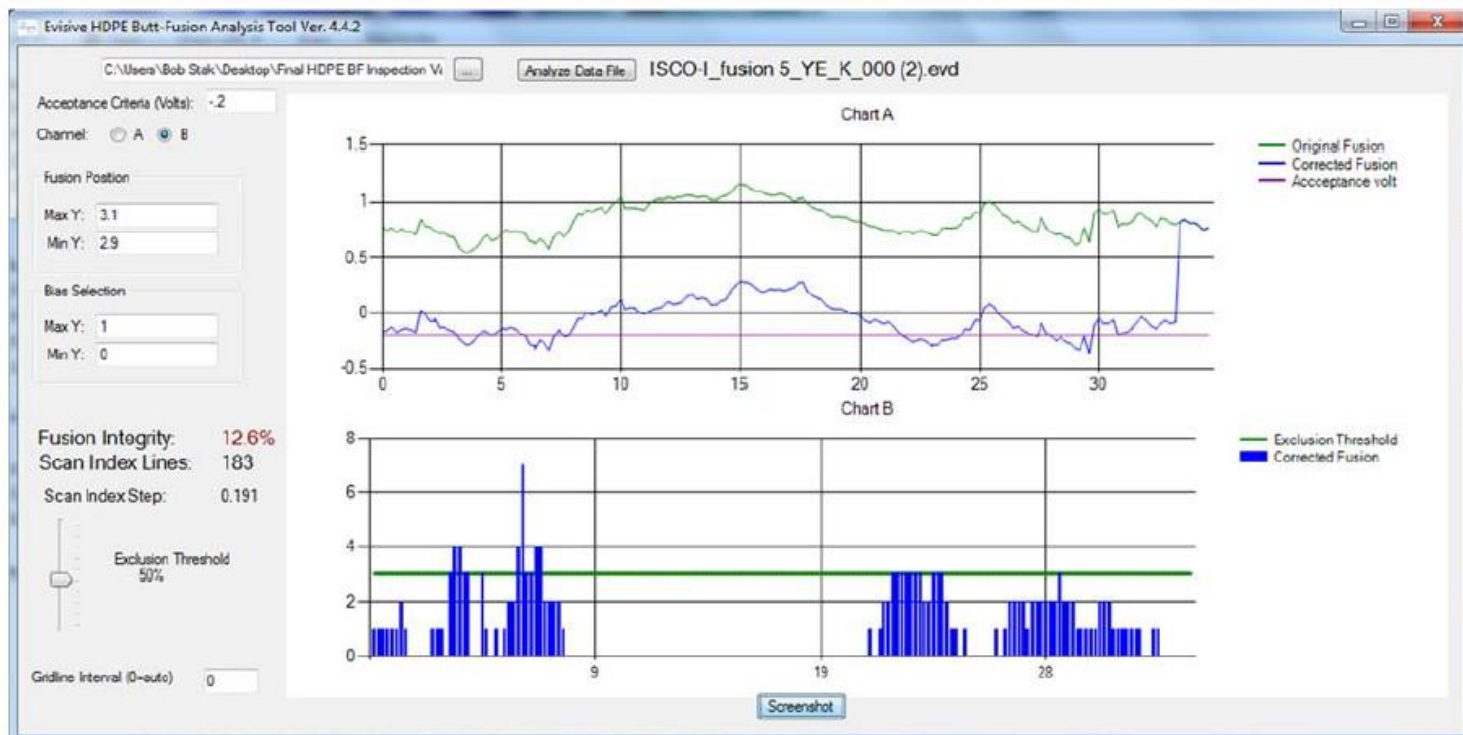
# Evisive Scan: Pass/Fail Software

"B" Channel Analysis Results showing a determination of 12.6% ductile for Fusion 5

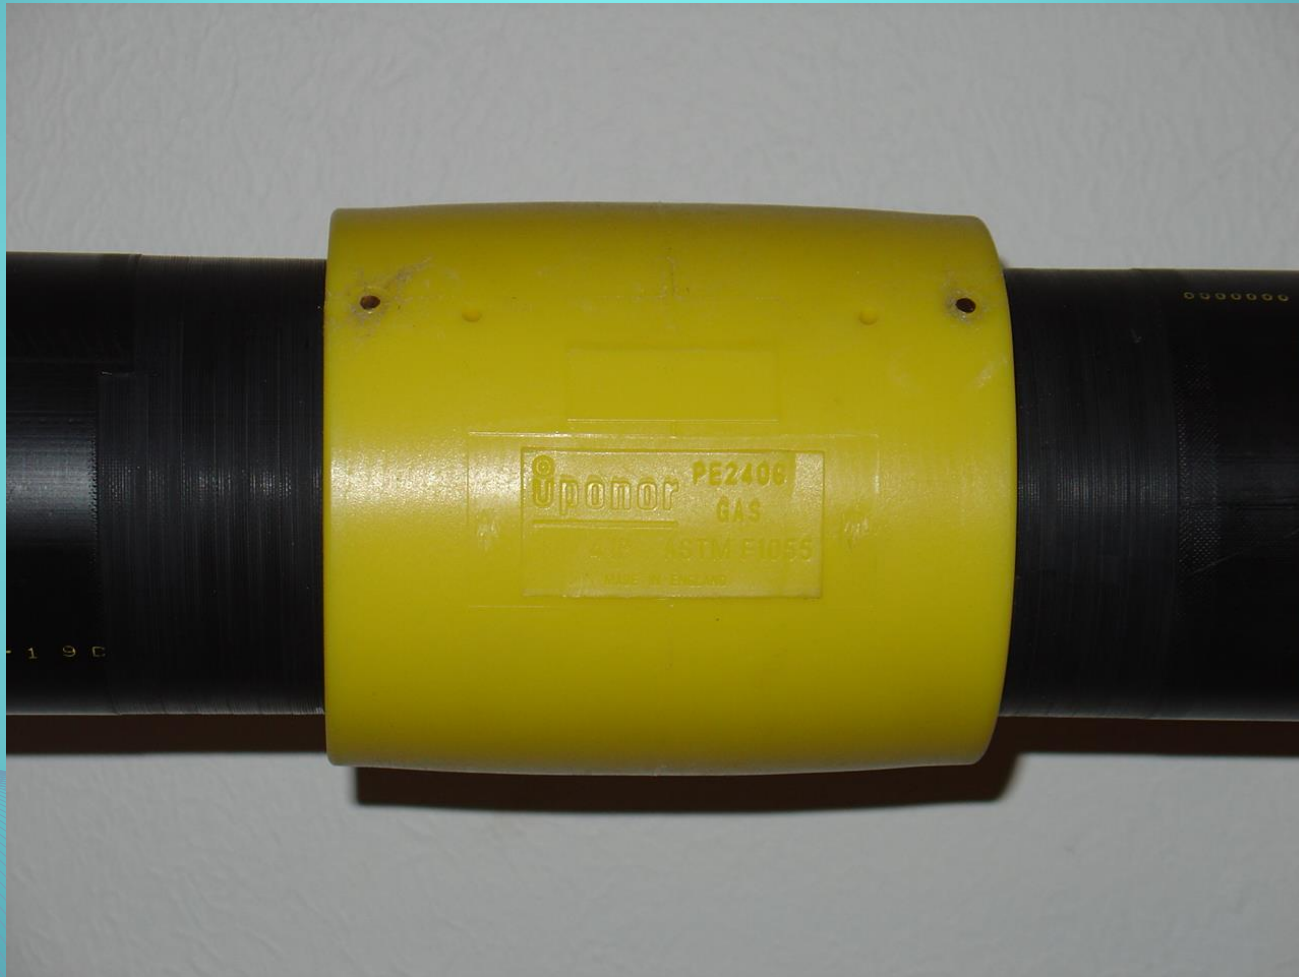
# Electro-Fusion Coupling

4" Electrofusion Coupling and Piping

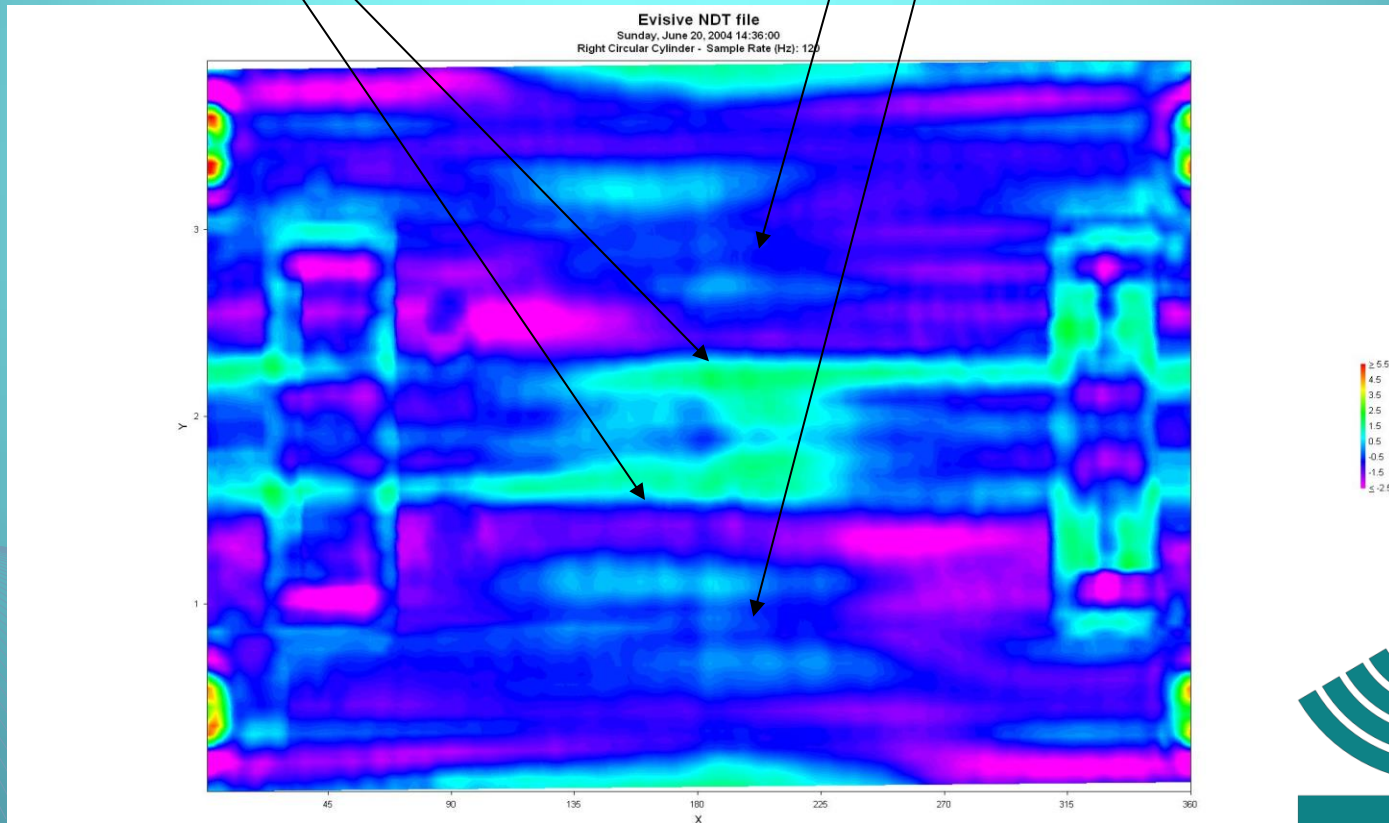
# 4 Inch Electro-Fusion Coupling

## Good Fusion

Edges of pipe shown at proper location

Lack of interest in fusion area-appropriate fusion

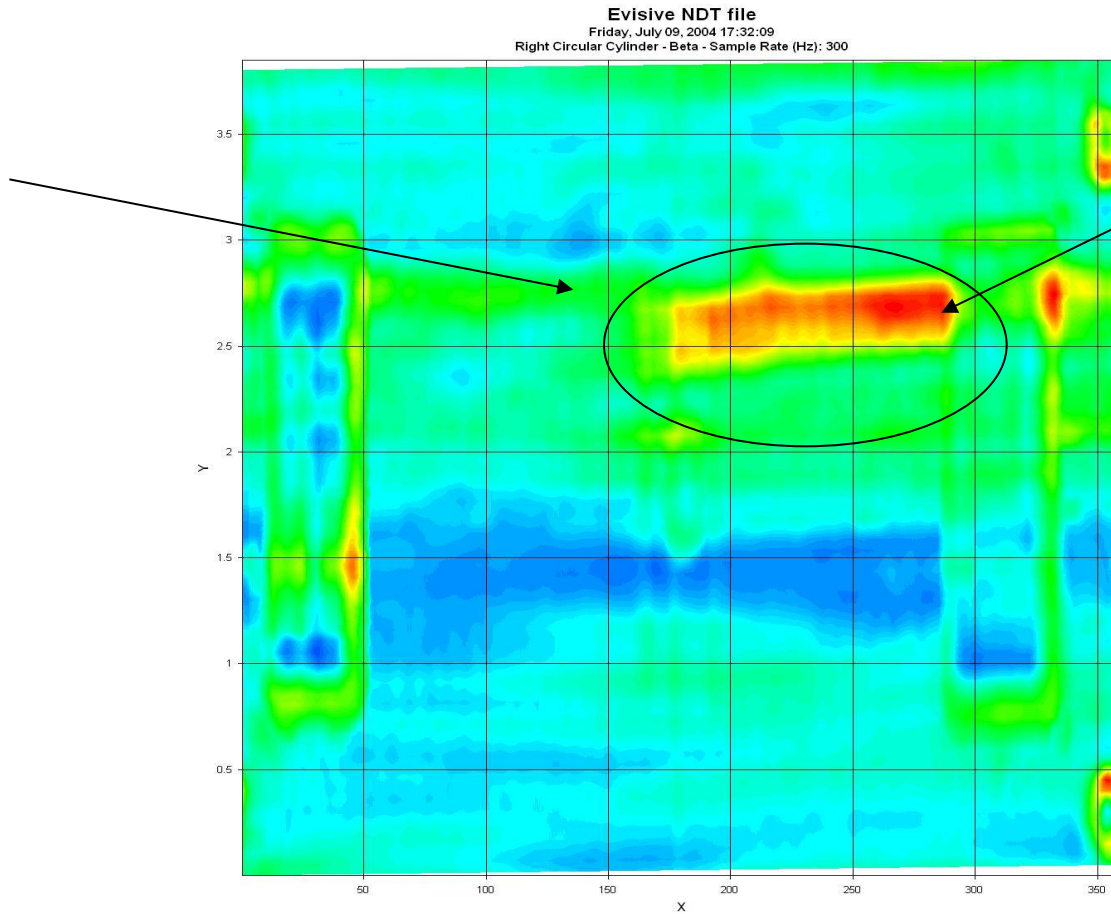
# 4 Inch Electro-Fusion Coupling Poor Insertion w/Melting

Edge of pipe at  
wrong  
location

Poor  
Fusion  
zone

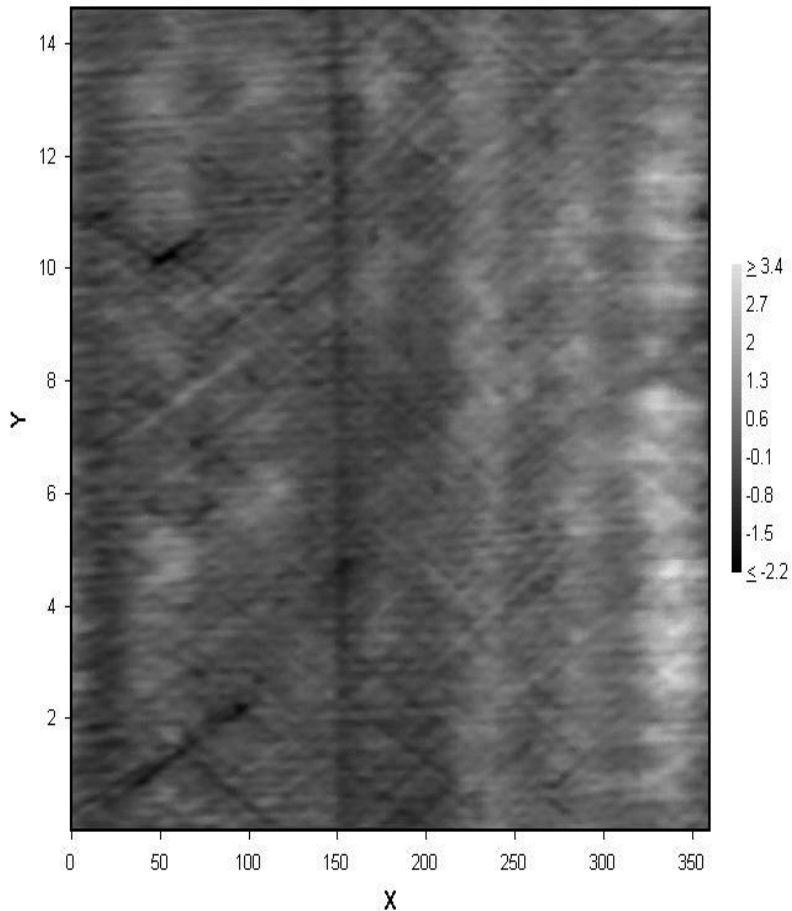
## Normal pipe section

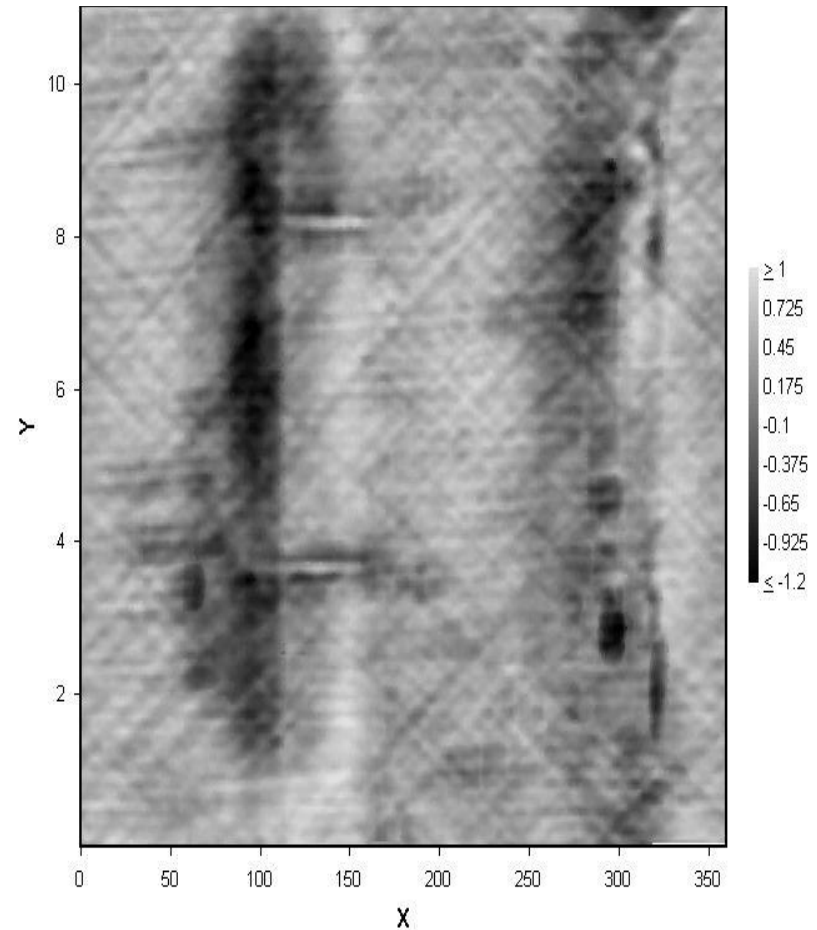
## Fibreglass Disbonded from HDPE

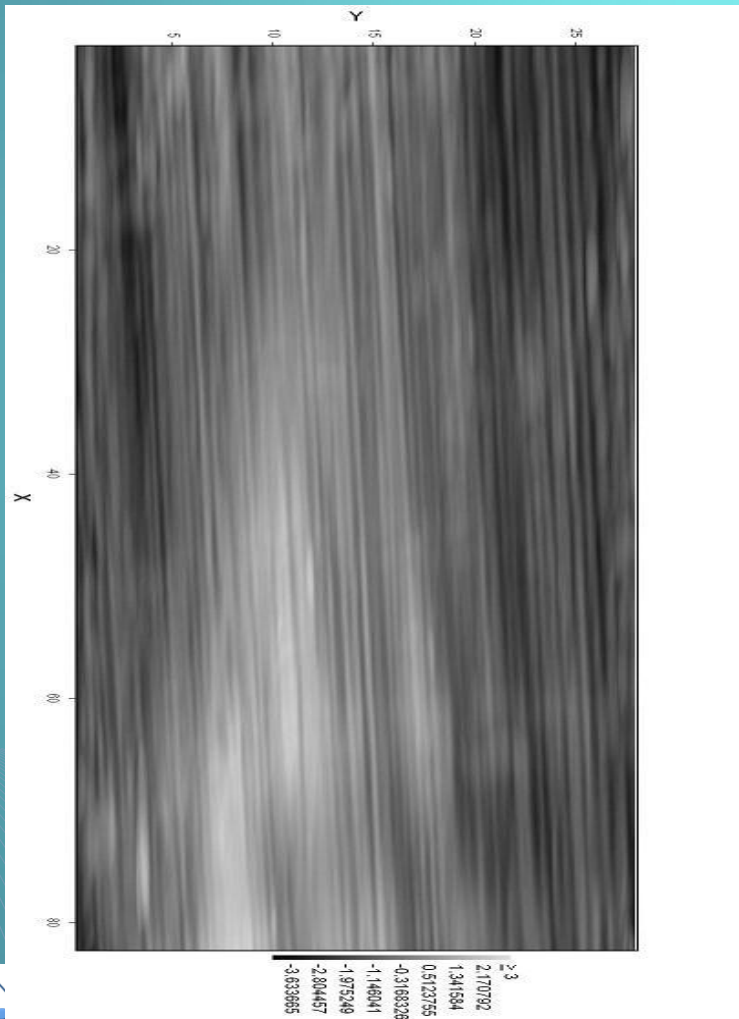
## Normal pipe section

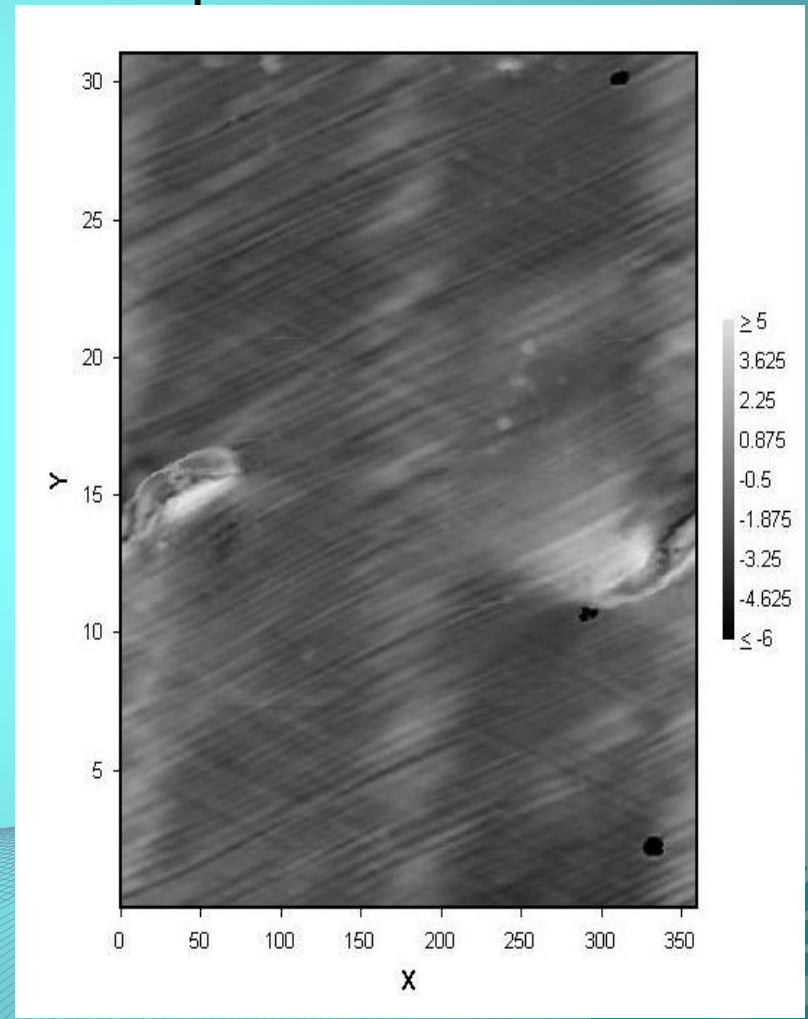
## HDPE ruptured under fibre wrap

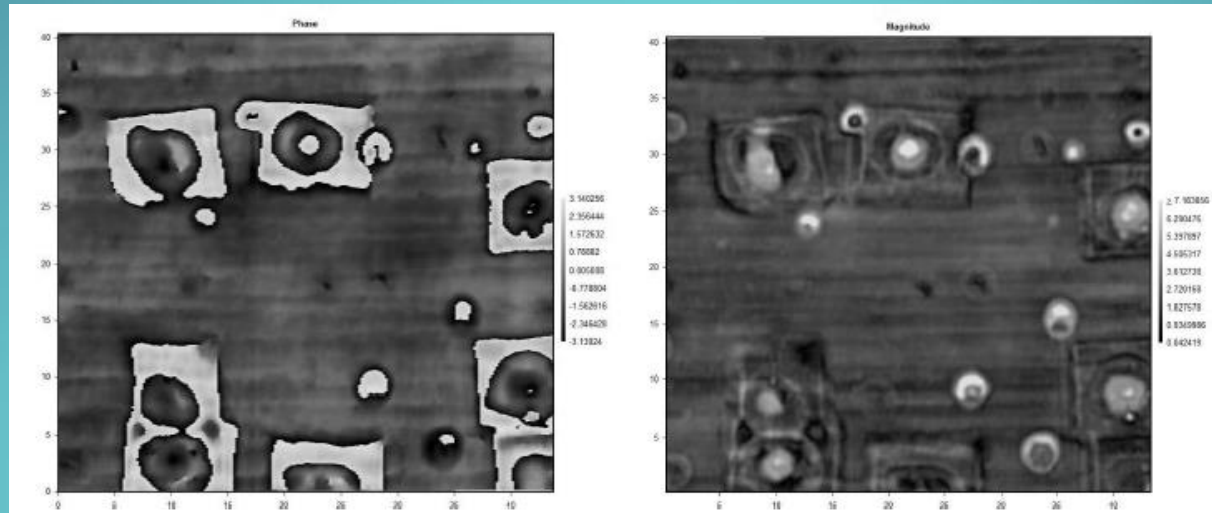
Figure 7.1: - Typical Standing Microwave Scan of customer's FRP tank wall. Left image is "Phase" and Right Image is "Magnitude"

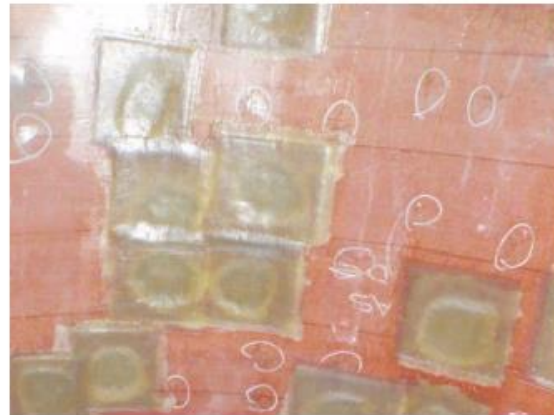
Figure 7.2: - Photograph of the inside surface of the inspected FRP tank showing features detected and characterized by the described standing microwave method

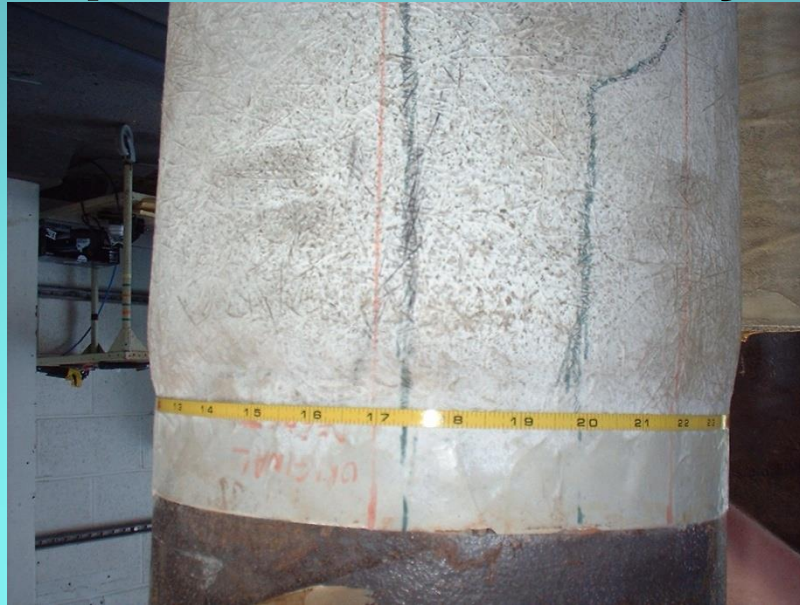
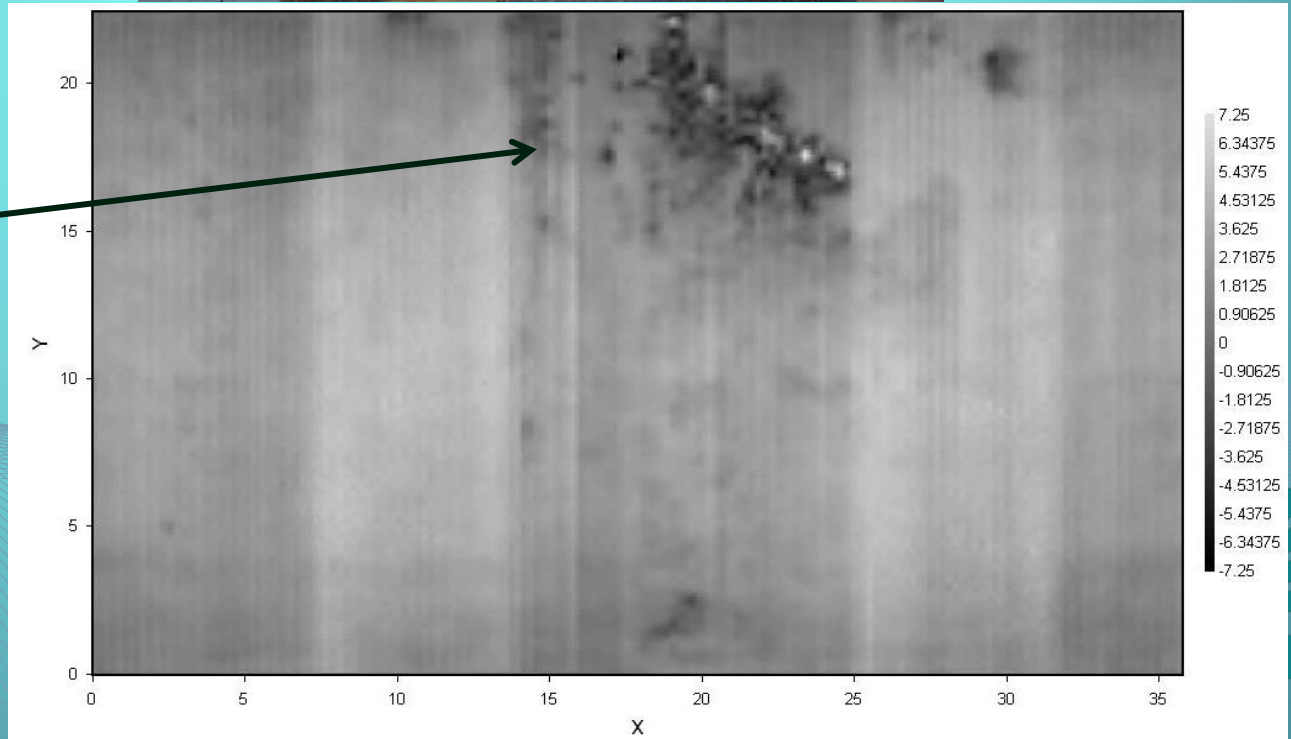
# Pipe Over Wrap with Intentionally Corroded Substrate

The known corrosion on the pipe can clearly be seen in the scan image

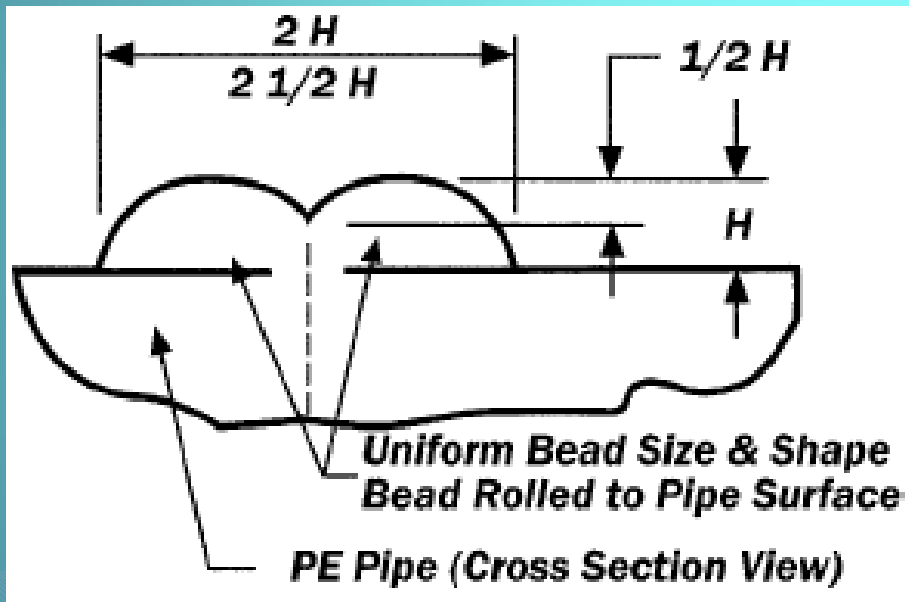
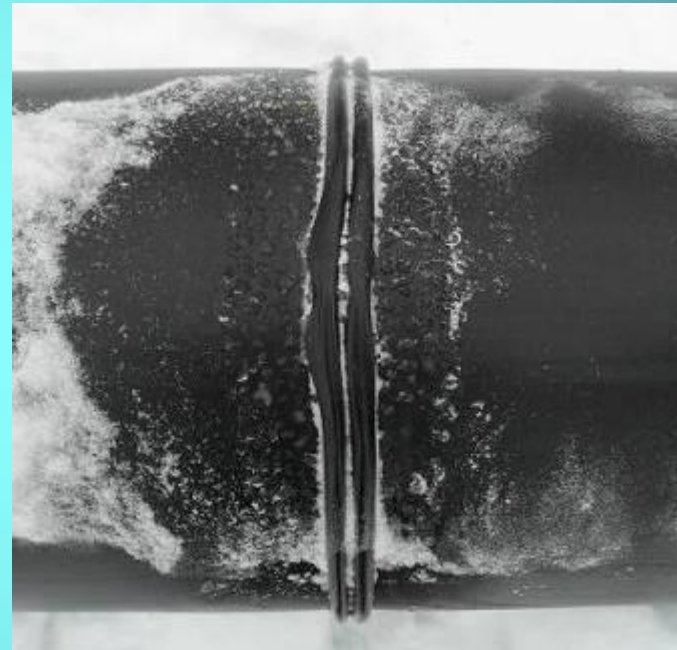
# Visual inspection can also provide information on fusion quality

But is still too subjective

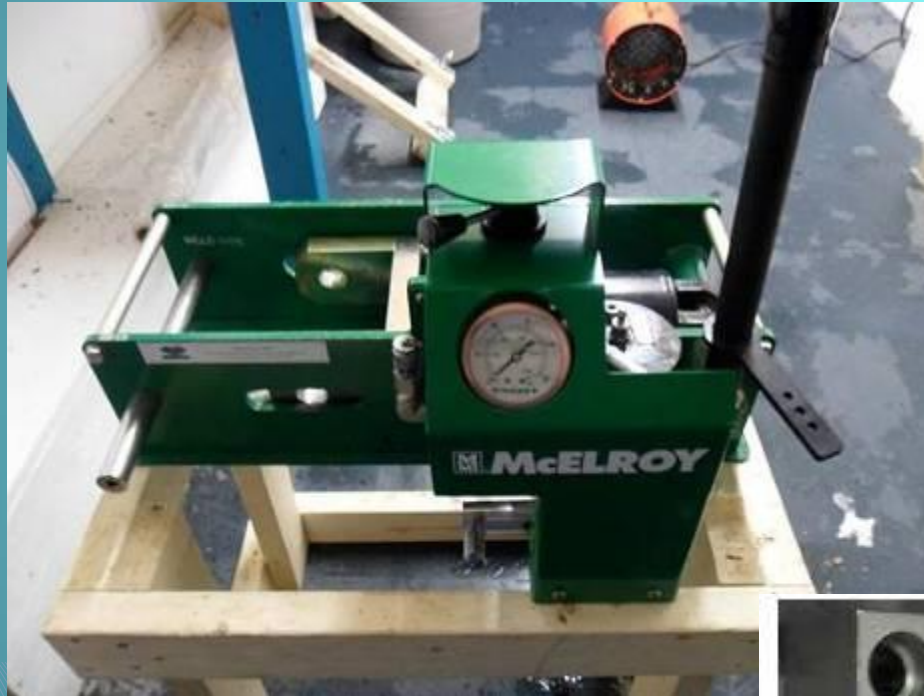
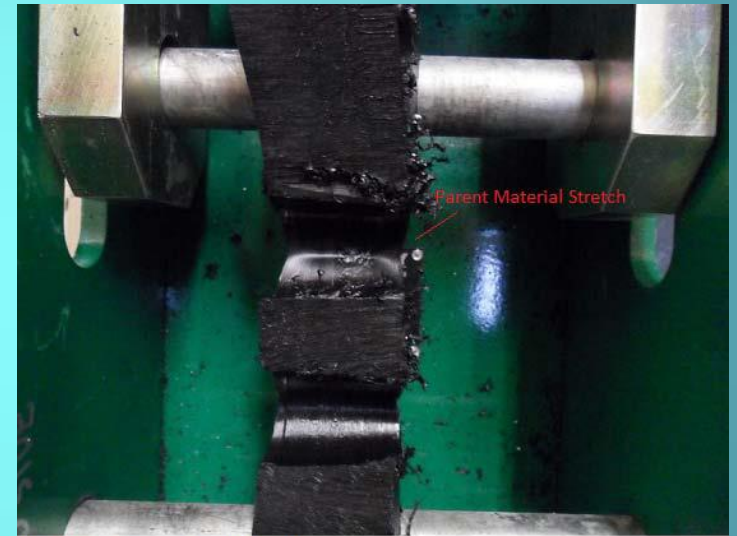
Pulling a typical pass on the tensile test

McElroy Field Tensile Tester

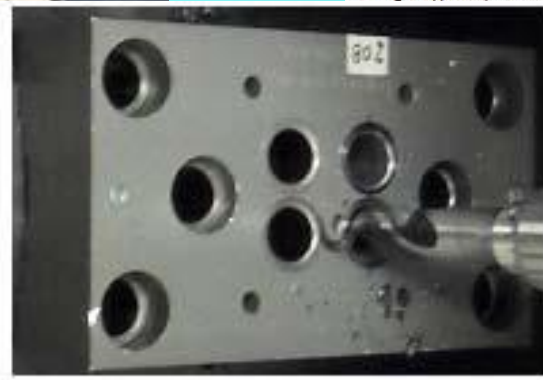
Additional benefit of FTT is the ability to view the fracture surface.

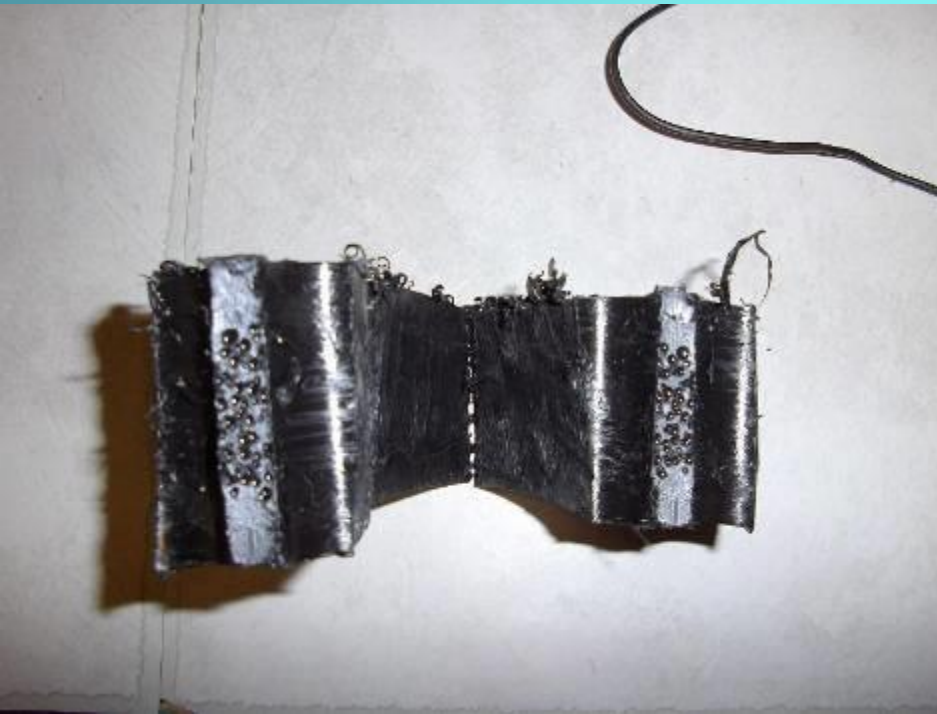
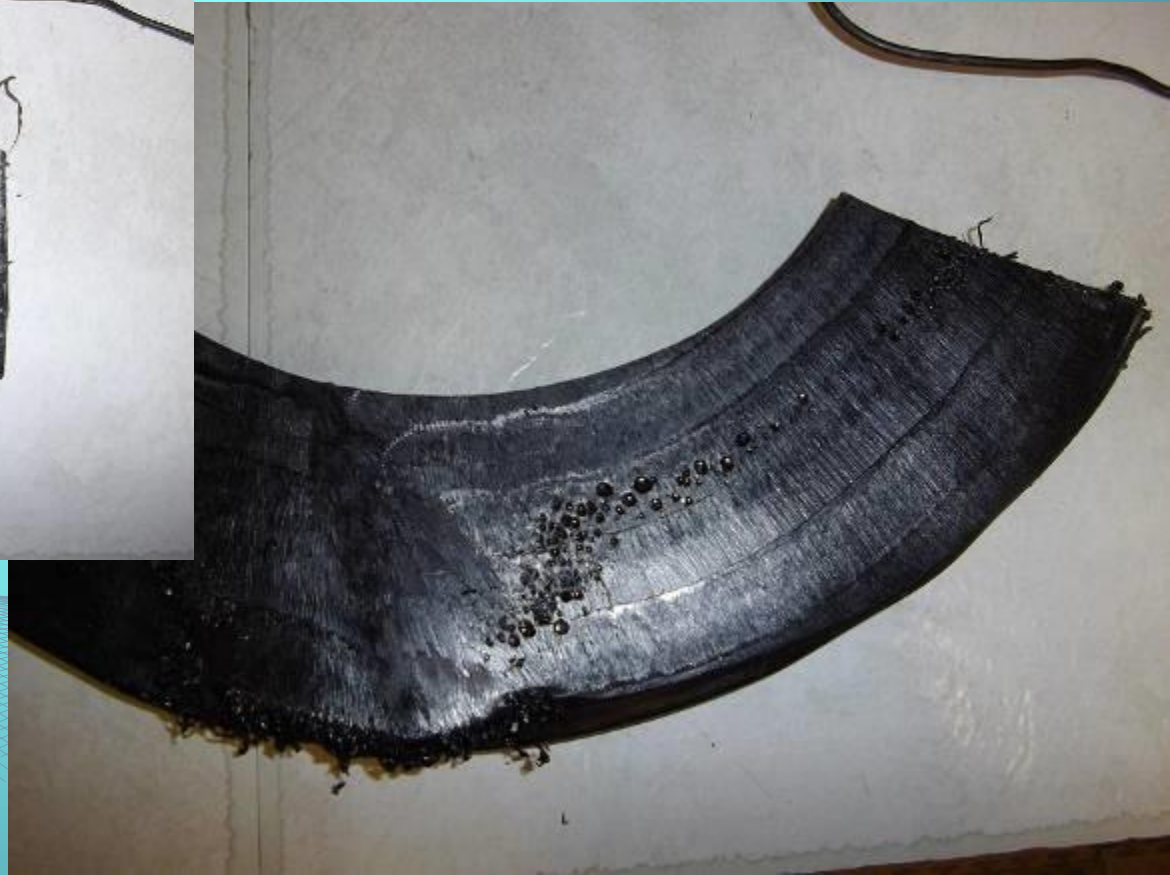
- FTT could detect issues with fusion surface

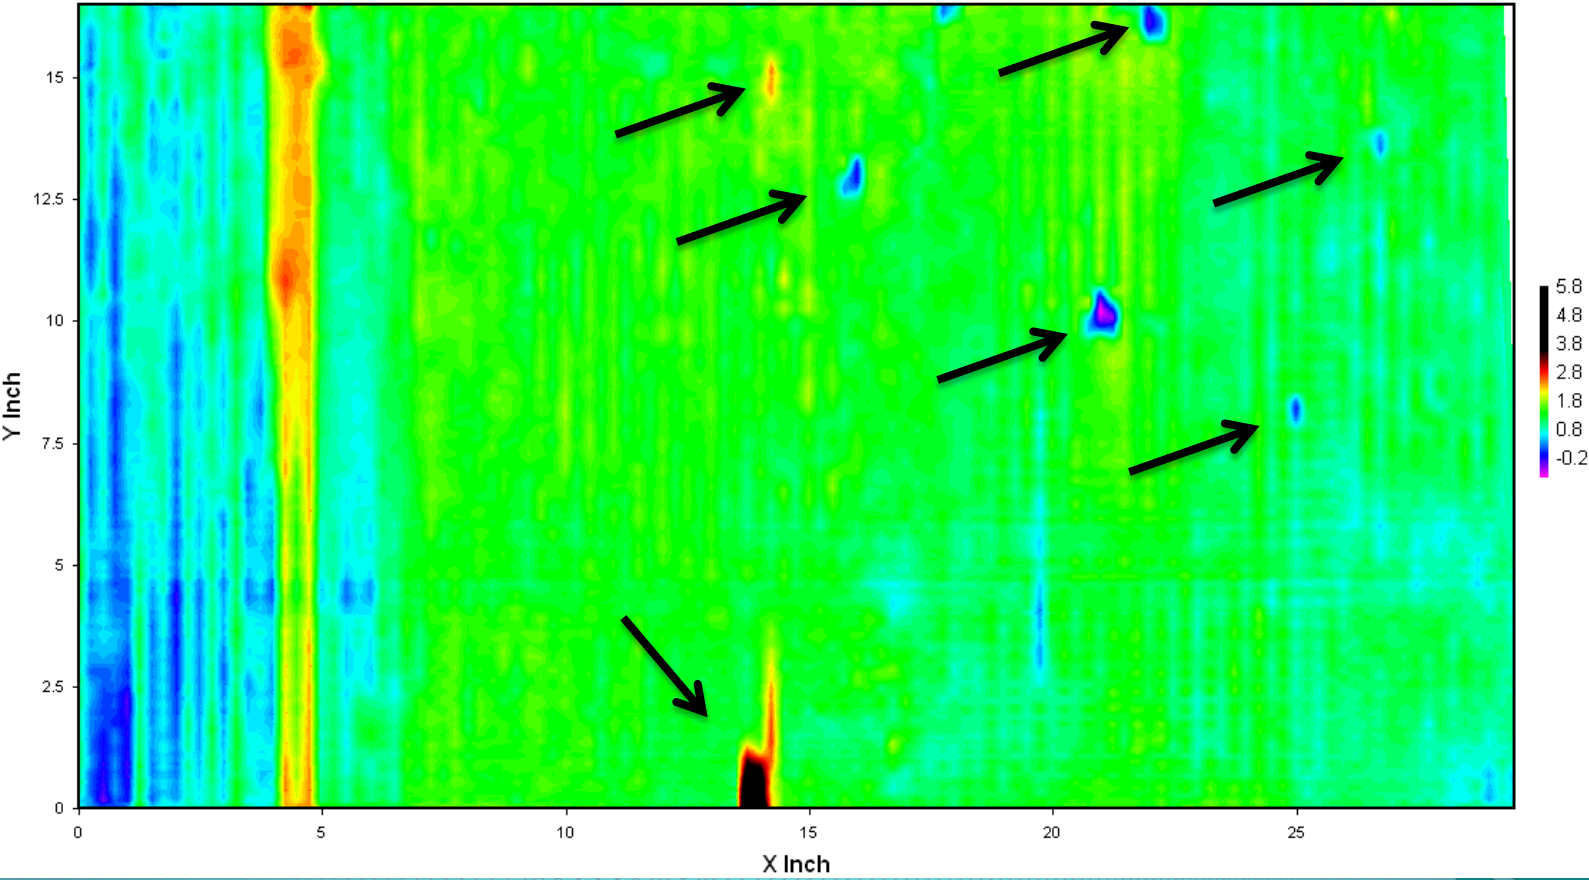
# Evisive Scan of Suspected Porous Pipe

Ch C - Evisive NDT file - 01-23-2011 17:42:36  
C:\Documents and Settings\Evisive\Desktop\taliman scans\10 test 4 jan 23.evd
